IMPLICATIONS OF ACI 288 ON INSITU NDT OF CONCRETE COMPRESSIVE STRENGTH

N Dimova, J Kwong, H Al-Abed, R De Bold, & MC Forde
University of Edinburgh
School of Engineering
The Kings Buildings
Edinburgh EH9 3JL
UK

KEYWORDS: Concrete, NDT, rebound hammer, ultrasonics, sonics, GPR, impact-echo, analysis, Impulse response (mobility).

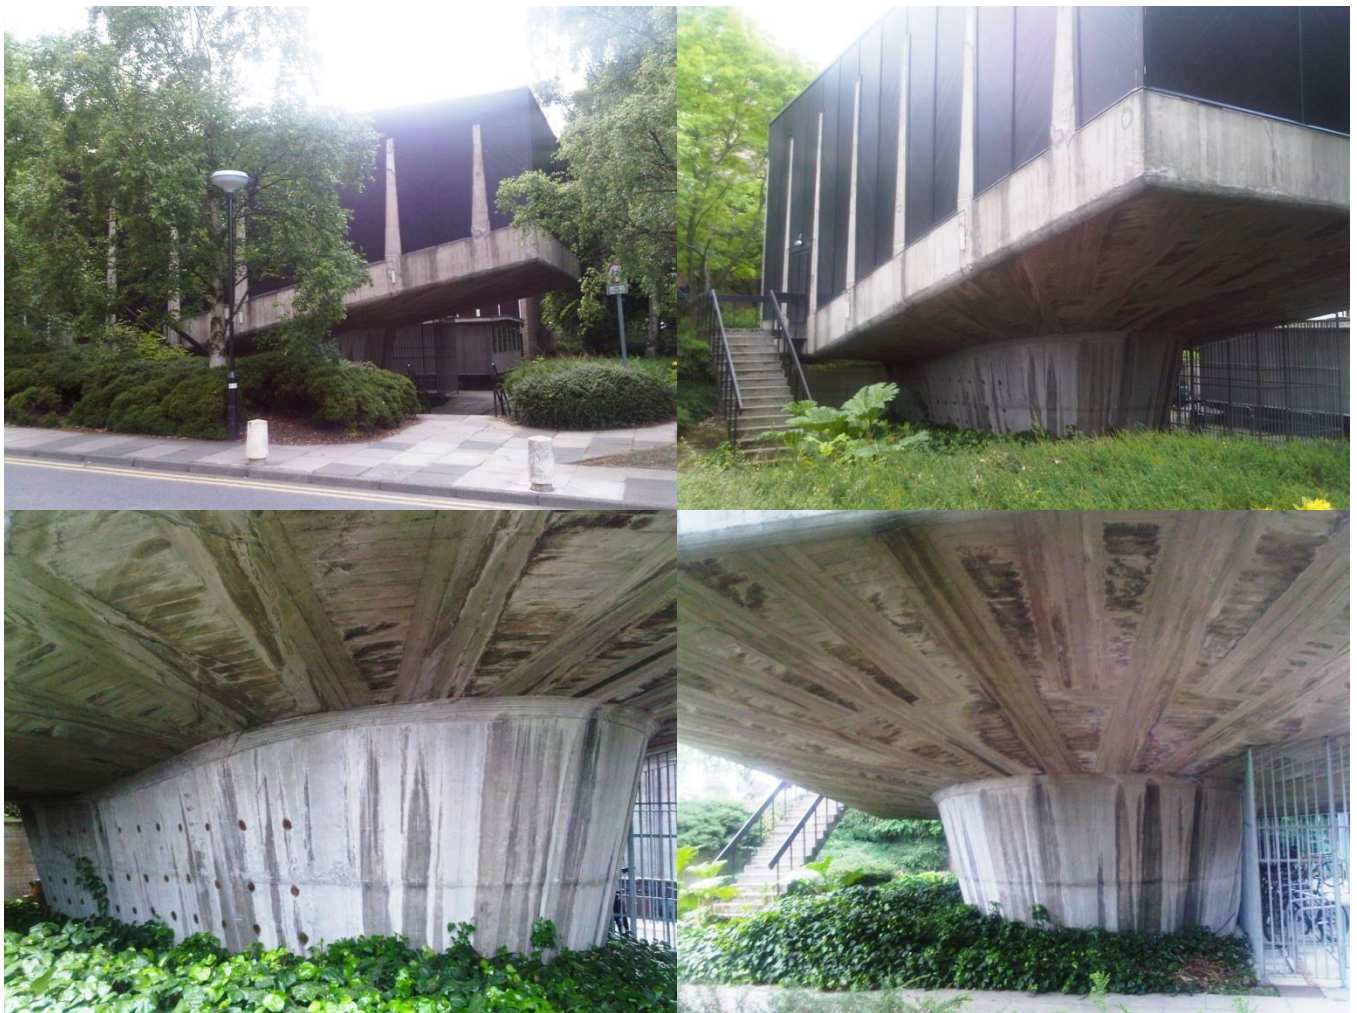
Figure 1 Engineering Lecture Theatre

As can be seen in Figure 1, the building cantilevers in three directions from a relatively small concrete base.

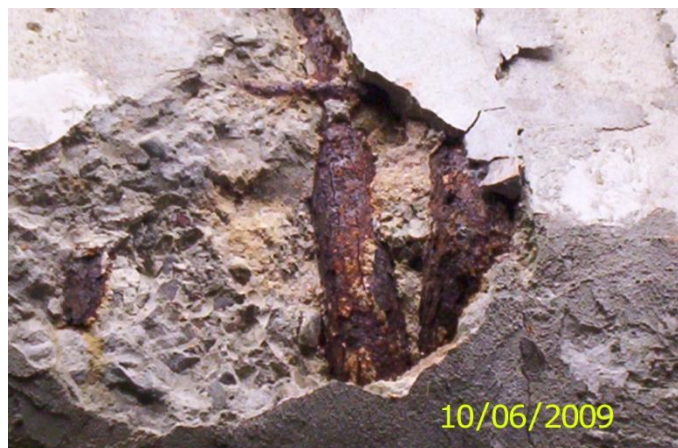
Figure 3 Exposed reinforcement

- In Figure 3, where reinforcement is exposed, it can be seen that there is hardly any depth of concrete cover, only a thin film of surface mortar that has subsequently fallen off; the exposed reinforcement has also become badly corroded. According to Section 3.3 of BS 8110-1:1997 (BSI), this does not satisfy the requirement minimum cover depth to reinforcement for fire protection, or to Section A4 of BS 8500-1:2006 (British Standards Institution) for corrosion protection.

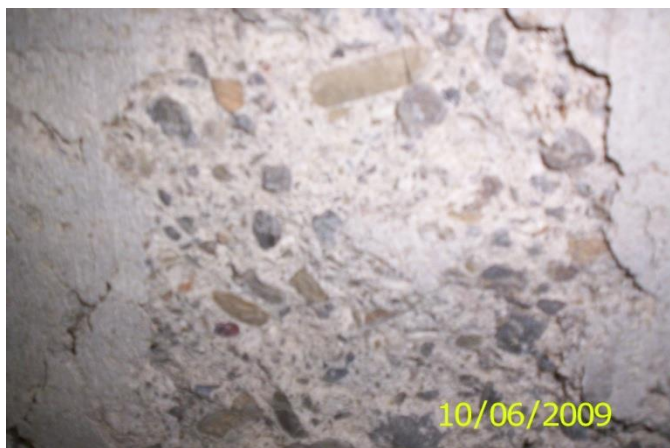
Figure 4 The matrix of the structure

- In Figure 4, where the concrete structure curves, parts of the concrete surface have come away in layers. It is important to note that the structure was not rendered; therefore, the concrete that has detached off is from the structural concrete.

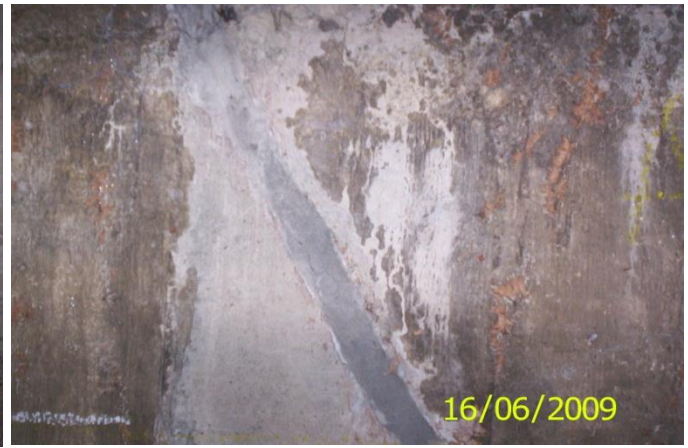
Figure 6 Minor repair on the structure

- In Figure 6, there have been some repairs made to the concrete surface indicating poor workmanship in the initial construction.

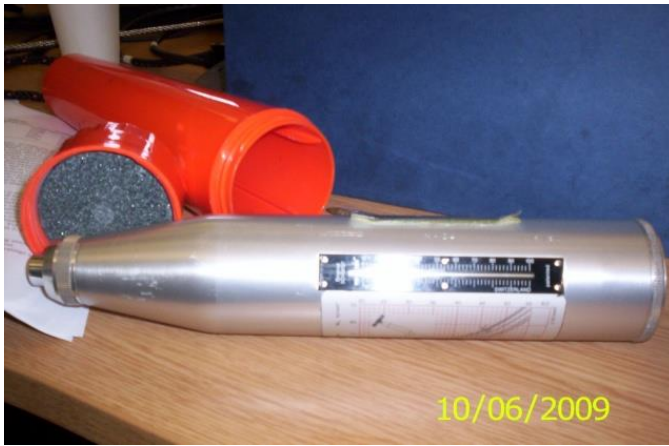
Figure 7 Hardness tester

Equipment: Schmidt rebound hammer
 Manufacturer: Proceq
 Supplier: ELE International Ltd
 Serial No: 108782

The equipment used was as shown in Figure 7. At least ten hammer readings were taken from each grid location. Additional readings were taken if specific results were considered spurious.

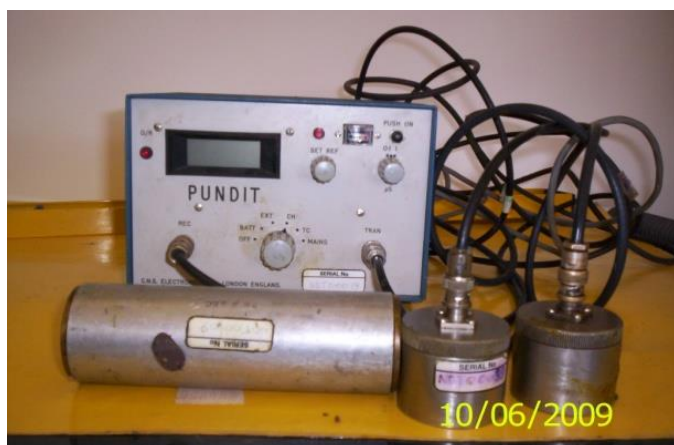
Figure 11 Ultrasonic tester

Equipment: Pundit
 Manufacturer: CNS Instruments Ltd
 Serial No: 8622174
 Transducer: 54MHz
 Calibration rod 26 μ s

The Pundit ultrasonic tester, as seen in Figure 1, was used on the concrete base structure where the Pundit transmitter and Pundit receiver were placed on numerous different locations on its surface.

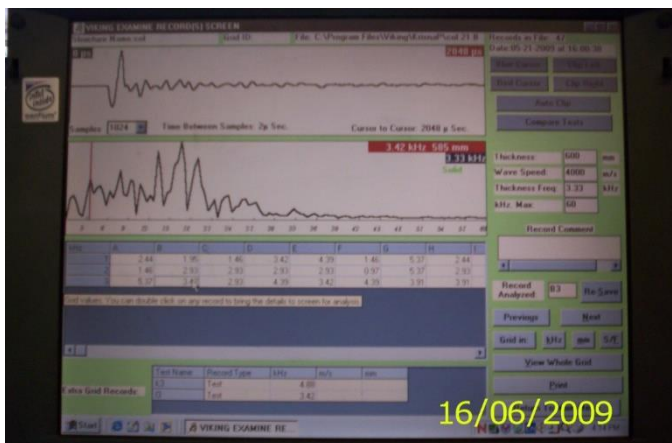
Figure 9 Impact echo software interface

Equipment: DOCTer

Manufacturer: Germann Instruments A/S

Transducer: Displacement transducer

The Mark IV transducer unit was mounted on the Star support with ball impactors and connected to the computer cable. The “Viking software” interface is as can be seen in Figure 9.

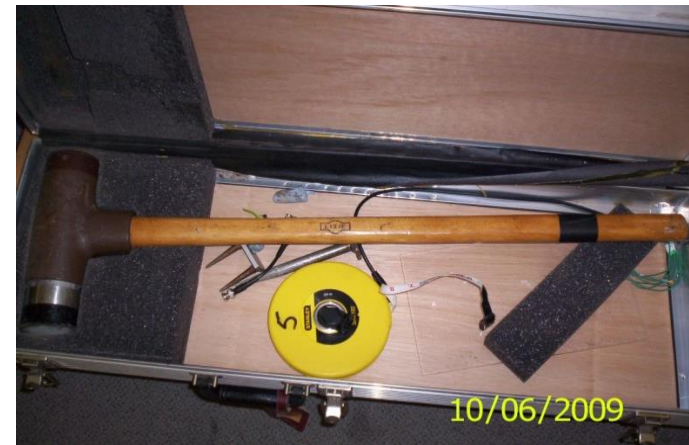
Figure 20 6kg Sledge hammer

The impulse response technique uses an impactor to send a stress wave through the tested element. The impactor is usually a modally tuned hammer with a built-in load cell in the hammerhead. Response to the input stress is normally measured using a velocity transducer (geophone). The hammer and the geophone are linked to a portable field computer for data acquisition and storage.

The impact-impulse hammer is seen in Figure 20, and equipment was setup as seen in Figure 1021.
